**Flood Control Project Maintenance  
Levee Inspections**

**Fall 2013 Levee Maintenance Deficiency Summary Report**

## Sacramento Maintenance Yard East Levee Yolo Bypass

**Levee Inspection Report By Mile - Fall 2013**

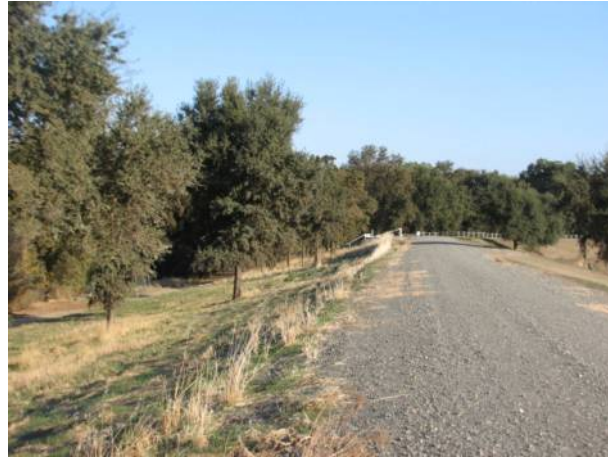
Levee Mile Report Line	4
Start Levee Mile	0.01
End Levee Mile	0.18
Location	Water Side
Category	Earthen Levee
Item	Vegetation

Plants and trees greater the two inches in diameter exist but do not obstruct visibility. Fall 2013

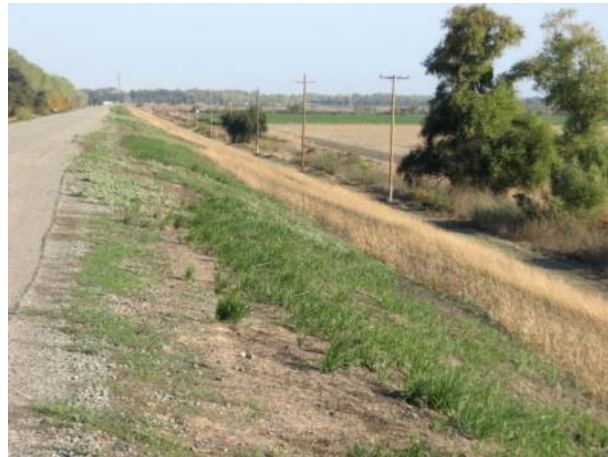
Levee Mile Report Line	5
Start Levee Mile	0.01
End Levee Mile	2.00
Location	Land Side
Category	Earthen Levee
Item	Vegetation

Better then 50% of the levee slope is grasses. Fall 2013

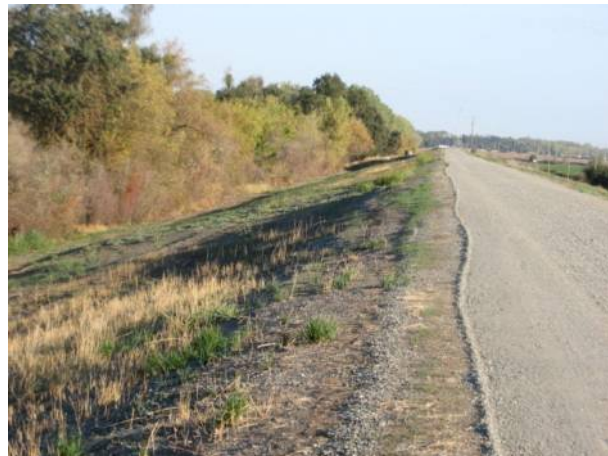
Levee Mile Report Line	6
Start Levee Mile	0.01
End Levee Mile	2.00
Location	Water Side
Category	Earthen Levee
Item	Vegetation

The levee has been burned and the grasses are beginning to grow. Fall 2013

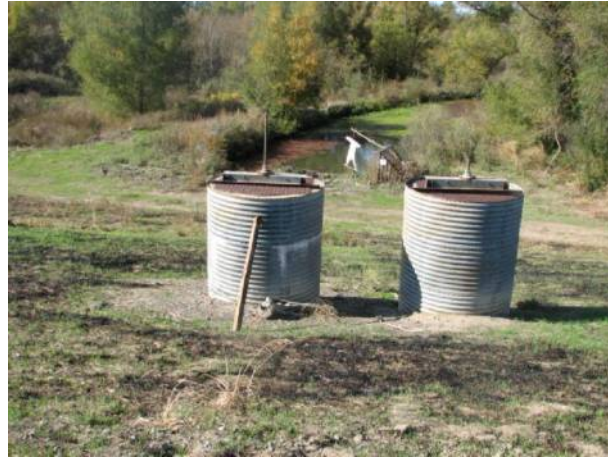
Levee Mile Report Line	8
Start Levee Mile	1.68
End Levee Mile	1.68
Location	Water Side
Category	Supplemental
Item	DWR UCIP Field Study

Waterside view: overview of CMP standpipe and water body
